# Ice Engineering

U.S. Army Cold Regions Research and Engineering Laboratory, Hanover, New Hampshire

## Remote Ice Motion Detection

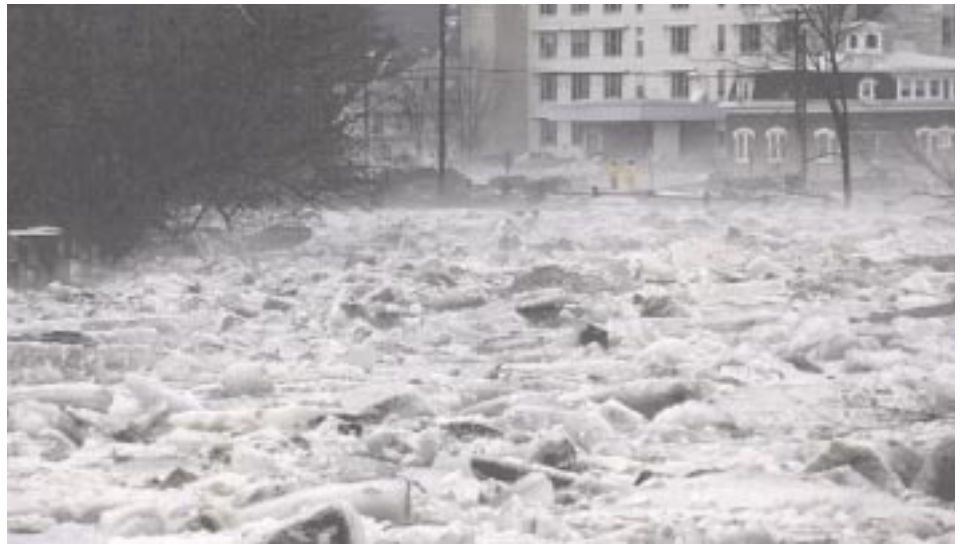
*Figure 1. This breakup ice jam, which occurred in March 1992 on the Winooski River in Montpelier, Vermont, resulted in damages of about \$20M. Following this jam, a monitoring system that includes ice motion detectors was utilized for early warning.*

Breakup ice jams can form suddenly, bringing about rapid fluctuations in stage, and cause flooding upstream (Fig. 1) and decreases in downstream discharge. Damage to riverine structures such as bridges, locks, dams, dikes, groins, levees, and riprap can occur. Ice jams have also affected navigation through delays, stoppages, and damage to tows, barges, and mooring/fleeting areas.

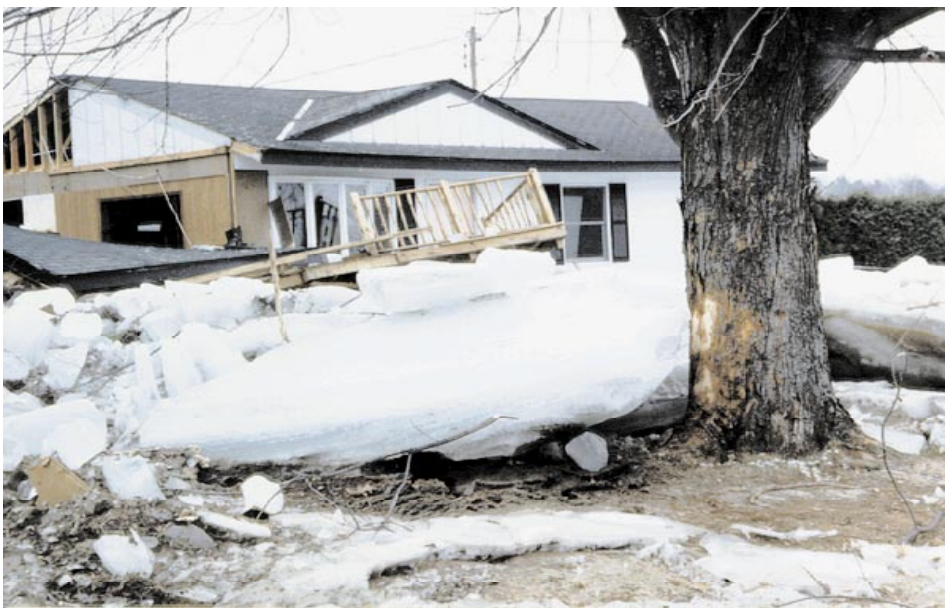
*Figure 2. With warning systems, residents can be evacuated before the ice conditions become dangerous. During the ice jam flood of January 1996 on the Saranac River in Morrisonville, New York, residents were evacuated from this housing development at night during dangerous ice and high water conditions.*

Ice-jam-induced scour may cause the erosion of streambeds and banks, with adverse impacts on fish and wildlife habitat, as well as the exposure of utilities buried beneath the stream bed. Emergency and medical relief to flooded areas may be limited by flooding or ice-related scour and erosion of roads resulting in road closures, or by the closure of bridges weakened or destroyed by ice. Evacuation can be difficult and dangerous during ice jam events (Fig. 2).

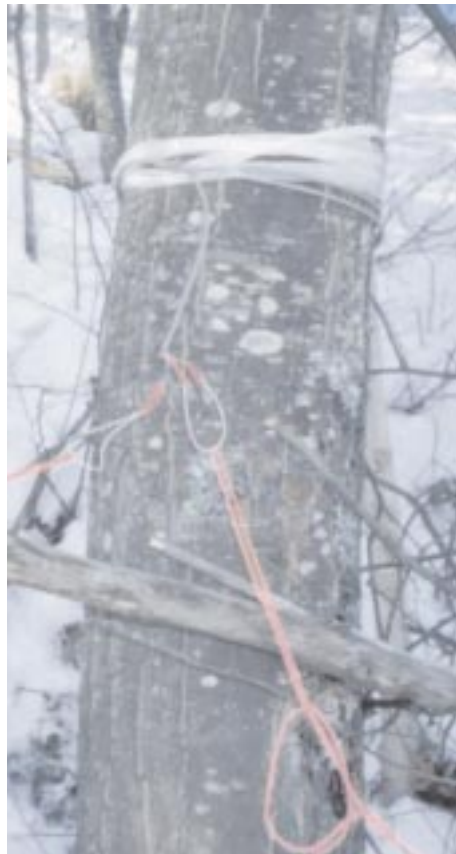
Figure 4. Connection between line embedded in ice (lower center), 28-gauge wire fuse (center), and signal-carrying line (upper center).

the ice motion detector (i.e., fused loop at detector connected to stronger line embedded in the ice). Instead, the fused loops were placed at the end of four-pair telephone wire, which was then connected to the dialer. One loop was connected to each pair, which carried the signal to and from the dialer (Fig. 4). Each loop was then connected to a stronger line that was anchored in the ice as shown in Figure 5. One loop leads to the approximate center-line of the river and the other to a point about a third of the way across the channel, beyond any hinge cracks that might be present.

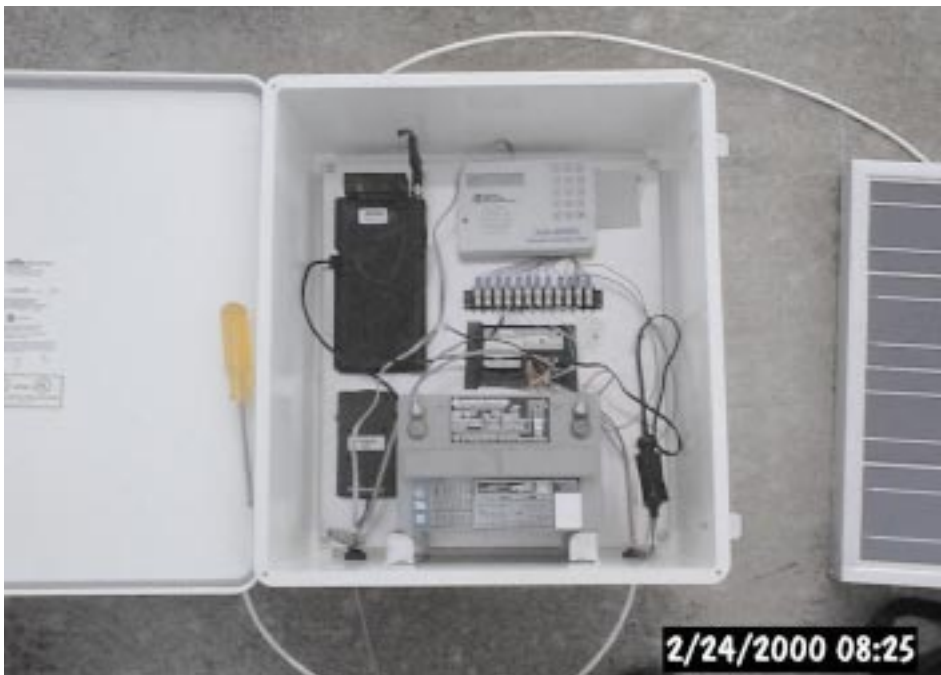
Figure 6. Remote ice motion detector system, with solar panel at right. Weatherproof enclosure contains (clockwise from upper left) automatic dialer, voltage regulator, gel-cell battery, phone/power interface, and cell phone.

The remote ice motion detectors utilized the same connection between the dialer and the ice cover, with the addition of a cellular phone, a 12-volt gel-cell battery, and a 50-watt solar panel to charge the battery (Fig. 6). All of the equipment is contained in a weatherproof enclosure that can be attached to a post or other safe location. Figure 7 shows a schematic of the system. The remote system does require cellular phone service, but minimal time is required because calls will be made only when testing the system and when the fused loops are broken.
